INITIAL PRODUCTION TEST OF
MARGINAL TERRAIN ASSAULT BRIDGE
WITH M113A1 LAUNCHER
(DAAK02-68-C-0226)

FINAL REPORT

6 MAY 1969

US ARMY
ARMOR & ENGINEER BOARD
FORT KNOX, KENTUCKY

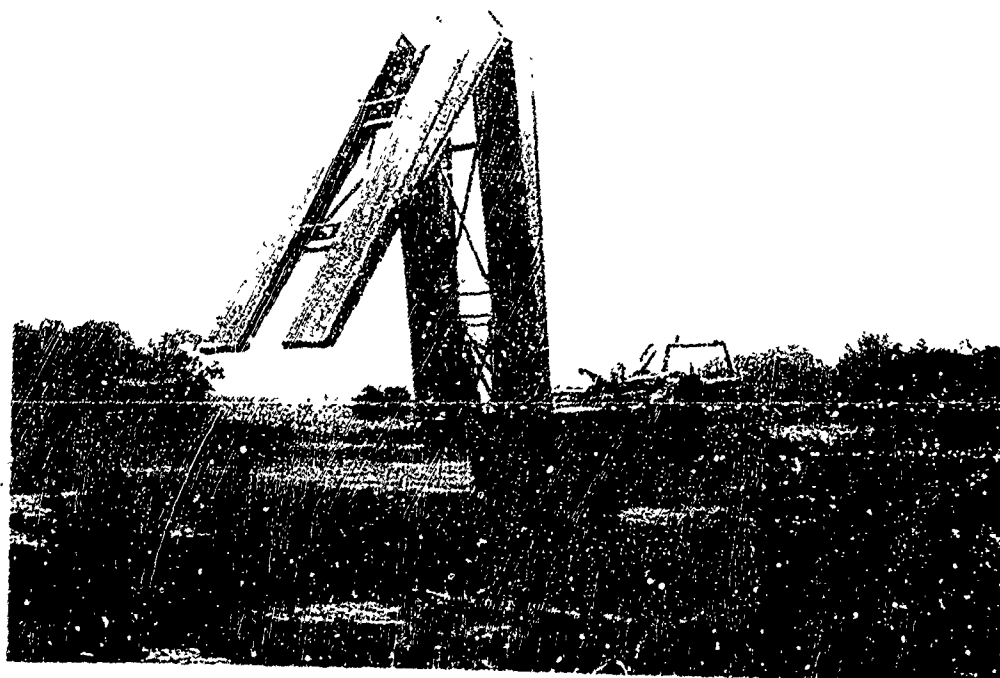
US ARMY ARMOR AND ENGINEER BOARD USATECOM PROJ NO 7-8-1018-06
FORT KNOX, KY PHOTO NO 5-2-28B

MARGINAL TERRAIN ASSAULT BRIDGE WITH
M113A1 LAUNCHER - LAUNCHING
